Urgent Field Safety Notice
Programmer Software Update
Supporting the Micra™ Transcatheter Pacing System

Model
2090 CareLink™ Programmer
29901 Encore™ Programmer
CareLink Network Application Software 2491

January 2019

Medtronic reference: FA856

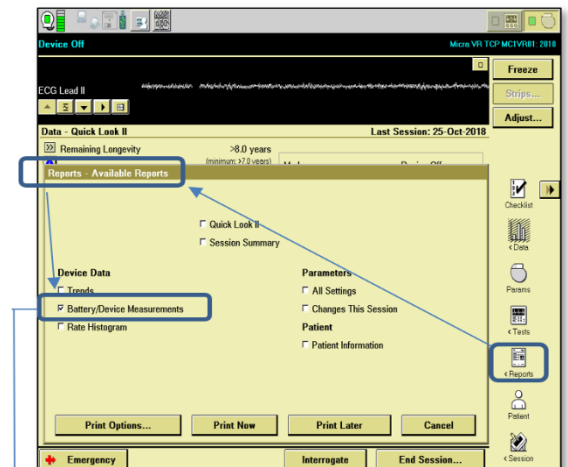
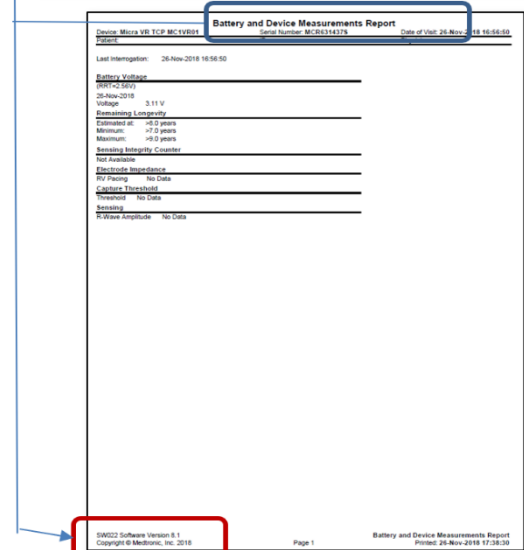
Images 2a and 2b

Any CareLink transmission completed after January 17, 2019 will report the updated remaining longevity estimate. For in-clinic patients who have been interrogated via a programmer, the clinician can view the Battery and Device Measurements Report (Images 2a and 2b) and verify that the Software Application Model ID located in the lower-left corner of the report indicates "SW022 Software Version 8.1".

- Select Reports (see image 2a)
- Select Battery/Device Measurements
- Click Print Now
- Verify the software version printed on the lower left-hand corner is "SW022 Software Version 8.1"
