Urgent Field Safety Notice

CFx Longevity Estimator Software Error

October 2019

Medtronic Reference: FA887

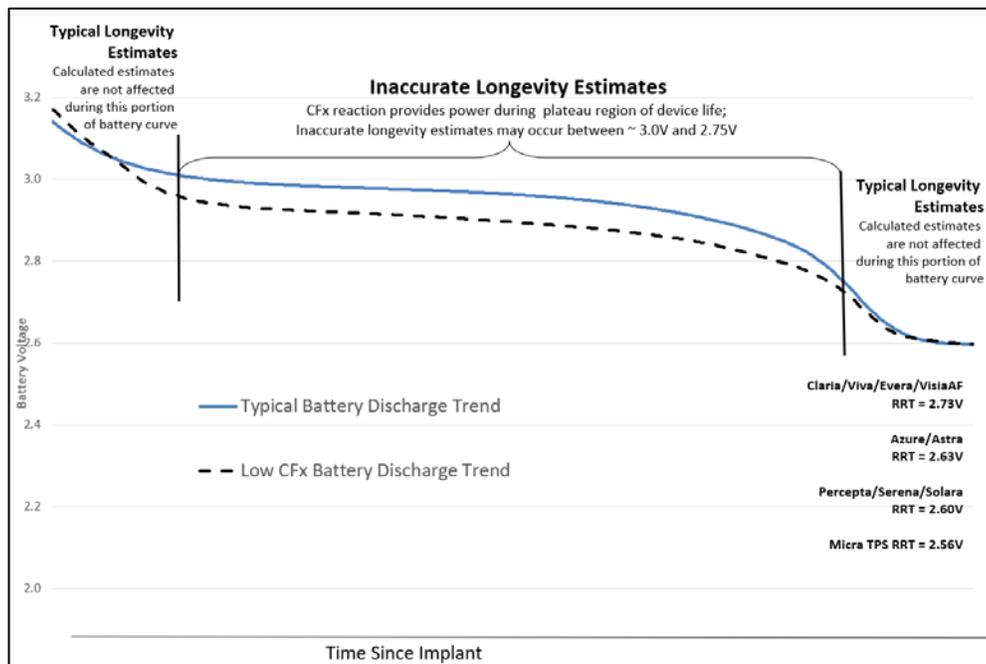
The inaccurate longevity estimation is limited to a well-defined subset of devices manufactured between October 2018 and April 2019, and only occurs in the middle (plateau) phase of the device life, as illustrated in the graph below. Approximately 53,100 devices worldwide, out of 1.23 million distributed or sold from the identified device families, are susceptible to displaying inaccurate longevity.

The cause of the inaccurate longevity estimate is a slightly lower-than-typical discharge voltage during the plateau phase of the battery depletion curve (dashed line), compared to a typical voltage plateau (solid line), as illustrated in the graph below. During this plateau period, the Carbon Monofluoride (CFx) in the battery cathode is powering the device. Note, longevity estimates early after implantation and later in the device life are unaffected, as shown below. The battery remains within operating specifications.

Software updates to programmers and remote monitoring systems are under development to correct for the inaccuracy in longevity estimates. Medtronic is targeting regulatory approval and release of the software updates to begin in mid-2020. Once available, Medtronic will inform you of the availability of the software and work with you to install the software onto clinic and hospital programmers. Software updates to individual patient devices will not be necessary to correct this issue, since longevity estimation resides on the programmers, mobile app and the CareLink Network

- **Prophylactic device replacement is not recommended**, as device functionality and the RRT indicator are not impacted by the inaccurate longevity estimate.

- Continue normal patient follow-up in accordance with standard practice.
- Per labeling, continue to use the RRT notification to identify when device replacement should be scheduled. Where available, utilize the low battery voltage RRT audible alert or wireless CareAlert™.
- At any time, if a lower-than-expected remaining longevity estimate occurs, contact Medtronic Technical Services for assistance – additional analysis of stored device information will be required to assess if the decreased longevity estimate is due to this issue.
