Urgent Field Safety Notice
Product Correction
 Urgent - Immediate Action Required

Date Issued September 16, 2019

Abbott has identified a potential reliability issue with the Alinity ci-series Level Sensor, Bulk Solution (LN 04S68-02). The details of the issue and the potential impact is described below.

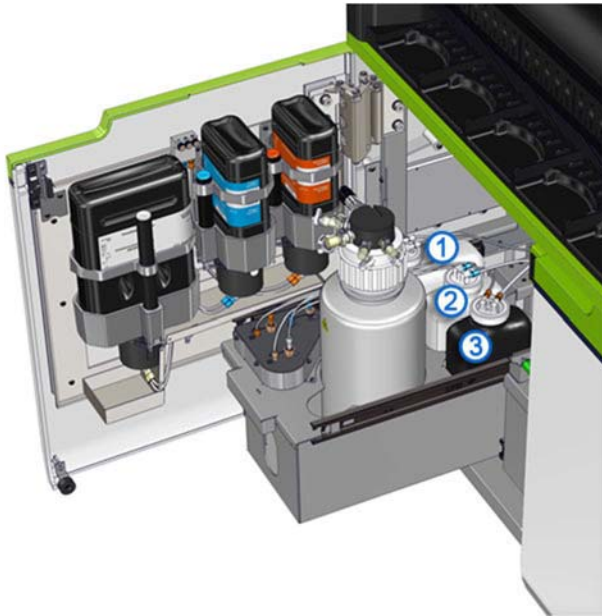
Bulk solution reservoir components (Alinity i)

1. Concentrated Wash Buffer level sensor
2. Trigger Solution level sensor
3. Pre-Trigger Solution level sensor

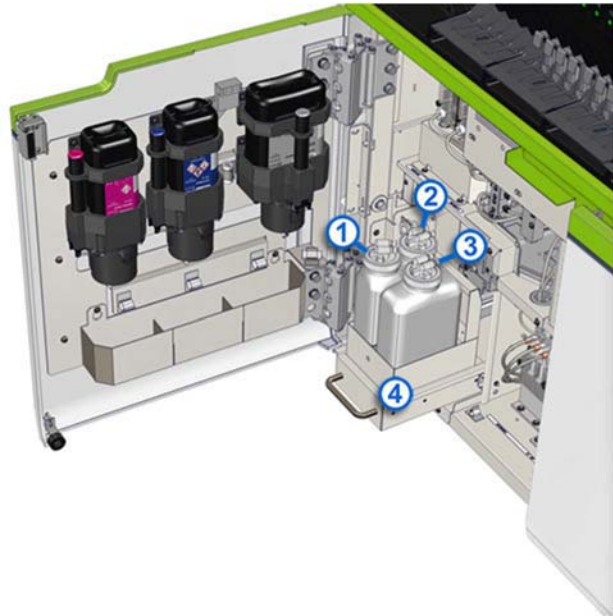
Bulk solution reservoir area (Alinity c)

1. Alkaline Wash level sensor
2. Acid Wash level sensor
3. ICT Reference Solution level sensor
4. Reservoir bottle tray

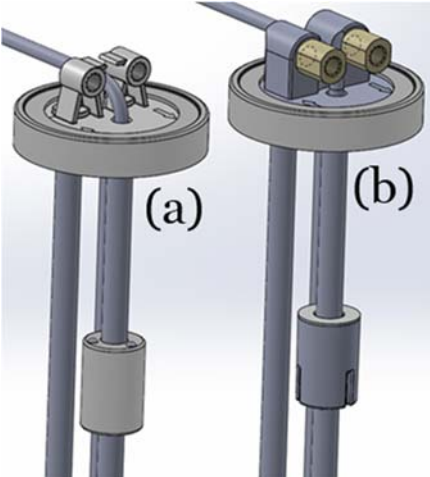
Figure 3. Identification of the Level Sensor, Bulk Solution (LNs 04S68-02 and 04S68-03)

(a) Level Sensor, Bulk Solution LN 04S68-02, (b) Level Sensor, Bulk Solution LN 04S68-03

Abbott has redesigned Level Sensor, Bulk Solution (LN 04S68-02) to improve reliability. The redesigned Level Sensor, Bulk Solution (LN 04S68-03) will be available beginning in the fourth quarter of 2019. You may continue to run the system using part number (LN 04S68-02) until the replacement parts (LN 04S68-03) are obtained by taking the recommended actions outlined in this letter. Once the redesigned Level Sensor, Bulk Solution (LN 04S68-03) is available, Abbott recommends the replacement of the LN 04S68-02 in all positions on the Alinity c and i systems.
