Cressier, 22nd December 2020

Field Safety Corrective Action / FSCA 004-20

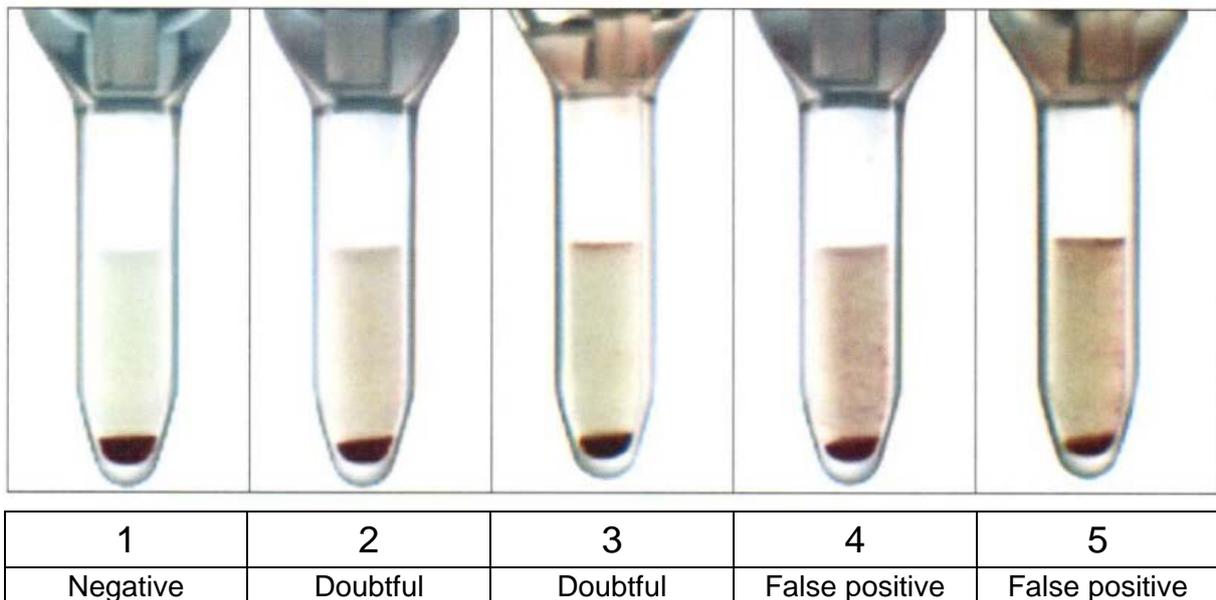
Figure 1_Example of nonspecific reactions observed in IAT

The root cause for both these phenomena is highly suspected to be related to the type of glass vials used in the manufacturing of reagent red blood cells.

The first phenomenon concerns nonspecific reactions primarily observed on QC samples but also with patient samples and eluates. Doubtful reactions or in some cases false positive reactions may occur randomly between batches and within a same batch. This phenomenon can appear with both manual and all automated methods.

The following are examples of the type of image that can be seen when the phenomenon occurs (image 1 in Figure 1 shows a normal negative reaction for comparison). These nonspecific reactions vary from doubtful (images 2 and 3) to positive (images 4 and 5) as shown in the figure 1 below.

The analyzer (Banjo ID-Reader, Saxo ID-Reader II, IH-1000, IH-500 or Classic ID-GelStation) may interpret a “?”, “wR”, “wF”, or “DP” (image 2 and 3 in Figure 1) or any option up to ++ (images 4 and 5 in Figure 1), depending on the intensity of the reaction.

In case you are facing the **nonspecific reaction** during the result validation (referring to figure 1), we recommend to:

1. Invalidate the result,
2. Repeat the test using non-open vials of the same lot,

If the issue persists,

3. Repeat the test with using a kit of a new lot,

If the issue is also observed using a new lot,

4. Use an alternative method.

If you work with the automatic validation activated, we recommend the visual confirmation of all positive results of indirect antiglobulin tests.

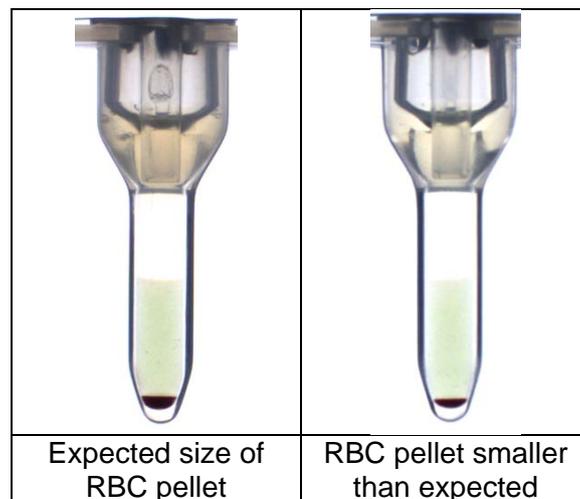
Figure 2_ Example of small pellet observed with insufficient red blood cell homogenization

The second phenomenon concerns insufficient homogenization of the red blood cells within the vials when stored on-board either on the IH-500 or on the IH-1000 and when the remaining volume reaches 2ml or lower. This lack of homogenization can lead to a dispense of low-concentrated red blood cell reagent into the wells of the ID-cards.

The following are examples of the type of images (Figure 2) that can be seen with small pellet compared to a well with expected red blood cell amount.

The **insufficient homogenization** leading to smaller pellets in the microtube occurs when the remaining volume of the reagent in the vial decreases.

If you detect smaller pellet than expected during the result validation (referring to figure 2 or comparing with other available result), we recommend to:

1. Invalidate the result,
2. Unload the reagent, swirl it gently to homogenize the reagent and load it back in the instrument,
3. Repeat the test,

If the issue persists,

4. Retest with a non-open vial

To prevent this phenomenon, particularly if you are operating under the automatic validation of the results, we recommend resuspending manually the red blood cells at least every hour by gently swirling the vials, when the remaining volume has reached 2 mL or lower.
