**Force  
 Definition AS  
 Definition Edge  
 Definition Flash  
 Drive  
 Confidence  
 EdgePlus**

**Customer Advisory Notice CT057/20/S**

running *syngo*.CT VB20A\_SP2

**Subject: Technical issue with several SOMATOM CT scanners running on *syngo* CT VB20A\_SP2, solved with the new service pack VB20A\_SP3**

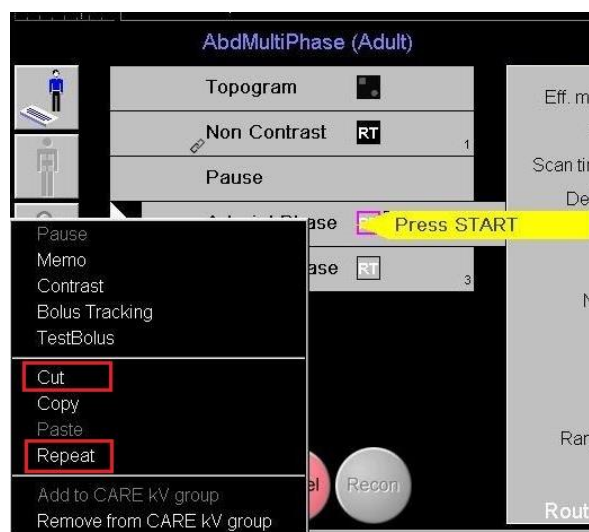
- A scan is loaded and the control box is flashing (“Press start” yellow message bubble is displayed) **and subsequently**
- A scan of the loaded protocol is cut or repeated (see Fig. 1)

Fig. 1: Context menu (right mouse click) offering the functions “Cut” and “Repeat” of a scan selected in the chronicle

In this situation it may be the case that the system will no longer accept any potential change to a scan or reconstruction-relevant parameter. Erroneously the changed parameters are displayed in the graphical user interface, but in fact the previous settings remain unchanged. Consequently, the original parameters will be used for the scan already loaded when the X-ray generation is started.

As the root cause, we found that the system does not trigger a cancel command followed by a reload of the scan with the new parameter(s).

Please cancel the scan already loaded **before** cutting or repeating an entry.

This issue will be solved by an improved *syngo* CT VB20A\_SP3 software version. A service pack will be rolled out free of charge with the update CT056/20/S for all affected systems. Its release is planned for the end of Q4/2020. All future service packs will contain the fix as well.
