Customer Safety Advisory Notice

CAN 001-2020

Re: **Symbia S and Symbia T system unintended detector motion**

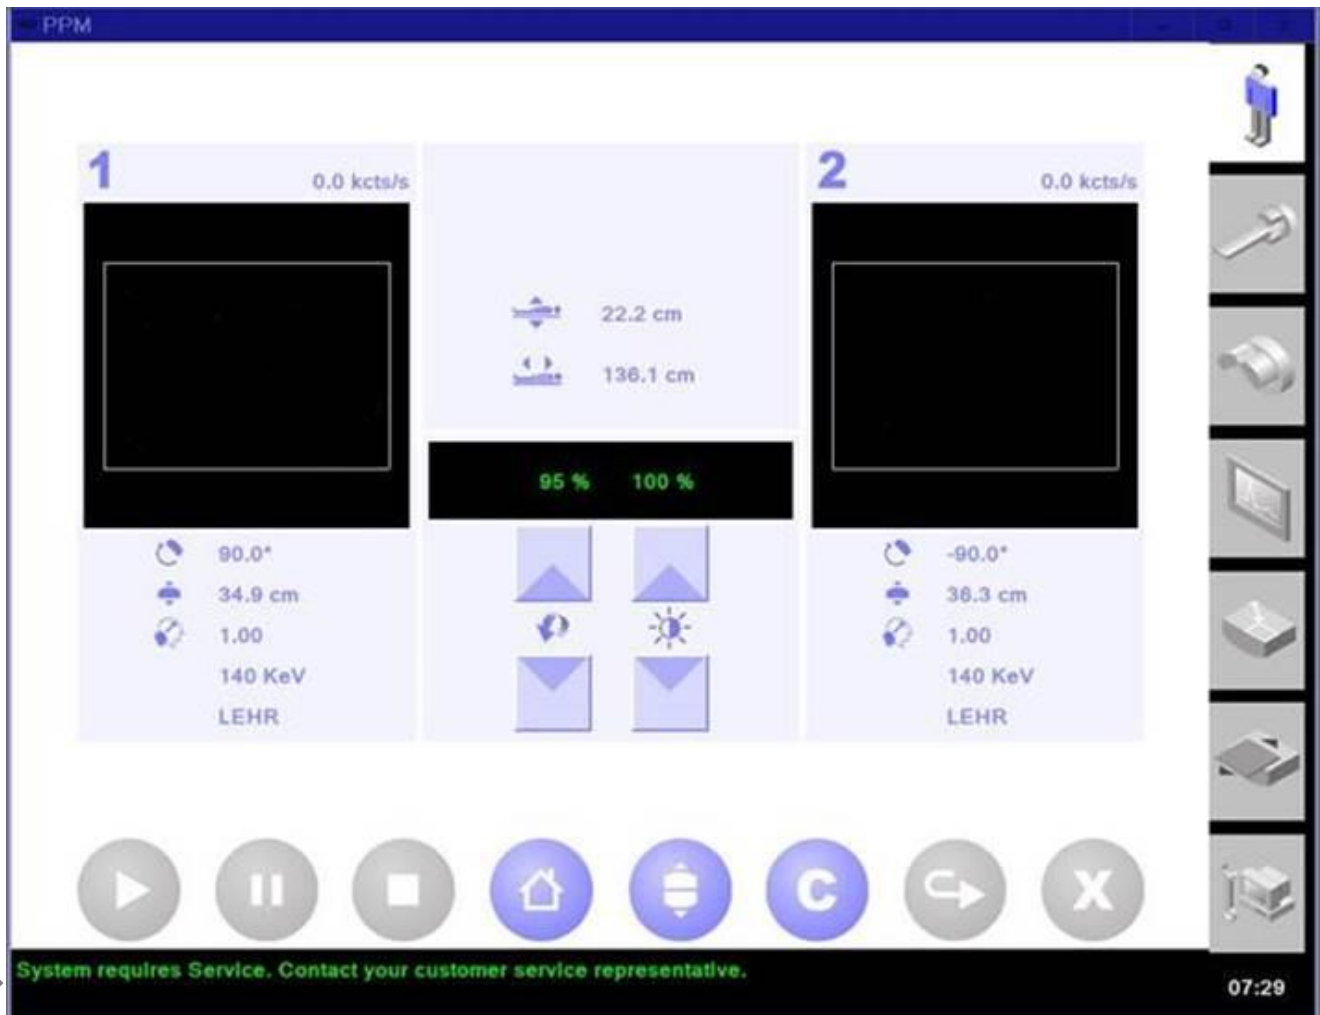
The issue may occur when a detector is moving downwards from roughly the 0 degree position radially towards the center of the camera bore, and an Emergency Stop press, touchpad engagement or power loss (ie: system shut down or power failure) occurs.

In this situation, the detector may continue to drift very slowly downward towards the center of the camera bore. If a patient is left beneath the detector, the detector may eventually contact the patient and potentially cause the patient compression related injuries. A detailed analysis determined that the likelihood of this issue occurring is improbable/highly unlikely, but not impossible.

If unintended detector motion is observed, downward pressure from the detector is reported by the patient at any time or the PPM presents a system error (as shown in the picture below), then manually retract the patient from the gantry using the patient bed handle and release button, stop use of the system and contact your customer service representative.

In the event of an Emergency-Stop, shutdown or power loss the patient should be manually retracted from the gantry using the patient bed pallet handle and release button.

Siemens Healthineers' service organization is addressing the issue through an extra scheduled service visit to check the detector motion system on possibly affected Symbia S or Symbia T scanners. Your local service organization will begin contacting customers beginning in the fourth quarter of calendar year 2020. If the inspection on your system fails, the related parts will be replaced restoring it to original factory performance. Afterwards, the detector motion system on all Symbia cameras will be routinely inspected during scheduled preventive maintenance visits to assure continued proper function.
