## To our customers of the Dräger Oxylog VE300 ventilator with optional carrying system holder

February 2019

### Important Safety Notice!!!

#### Possibility of the Oxylog VE300 falling out of the carrying system holder. Only devices specified in the attached serial number list are affected.

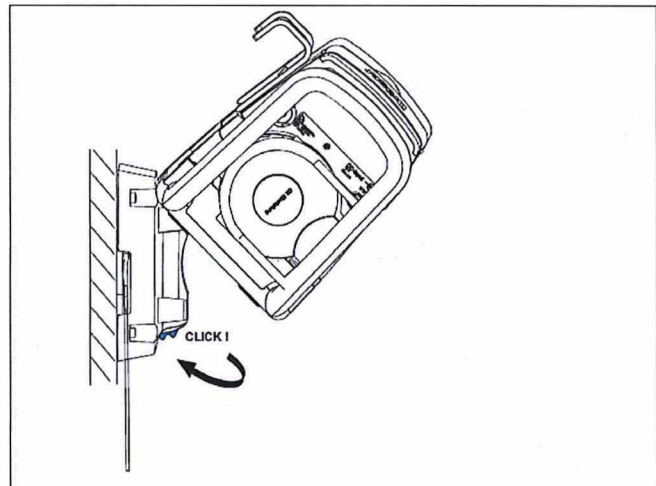
- 1 Insert the device in the middle of the upper socket.
- 2 Press the device into the lower latch until it audibly clicks into place.
- 3 Make sure that the device is properly secured.

The Oxylog VE300 ventilators with carrying system can continue to be used safely. To do so, it is necessary to attach the device to the carrying system holder as described in the Instructions for Use of the carrying system holder, and to ensure in particular

1. that the device is inserted in the middle of the socket (parallel to the wall-mounted plate) and
2. that the device is correctly latched into the carrying system holder and
3. as a final step to check that the device is properly secured by pulling the handle.

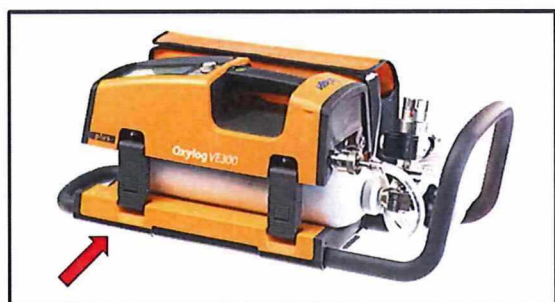
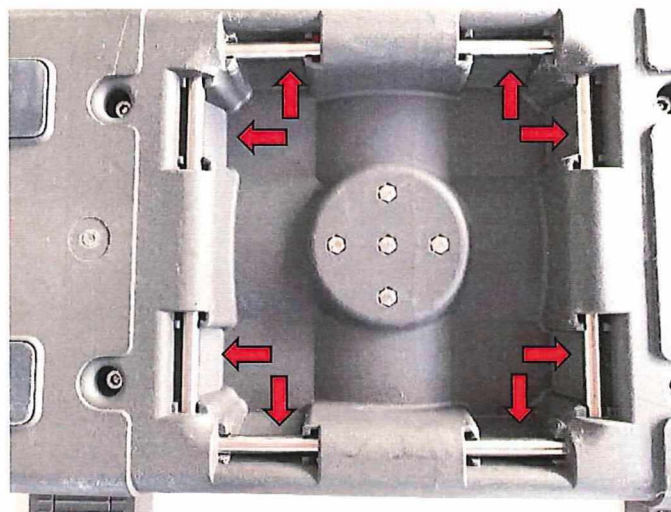
Within the framework of our continuous market surveillance activities, a case has come to our attention in which the Oxylog VE300 ventilator became detached from the wall-mounted carrying system holder. This was because an axis was missing from the attachment mechanism on the bottom of the device. The missing axis meant that the device was not firmly latched into the carrying system holder. No patient or user was injured in the reported case. However, due to the weight of the device, it is not possible to rule out the risk of injury if the incident were to recur.

Furthermore, we would like to ask you to carry out an additional check. Before using the device, please verify that all 8 axes are present and in the correct places, as shown in the pictures below.

Please do not continue to place the device in the carrying system holder if you detect any inconsistencies in the attachment mechanism.

Your local DrägerService will contact you to organize replacement of axes in the attachment mechanism by a new and improved version of axes.
