Urgent Field Safety Notice
Medtronic HeartWare™ HVAD™ System
 Customer Notification

August 2021

Medtronic reference: FA1180

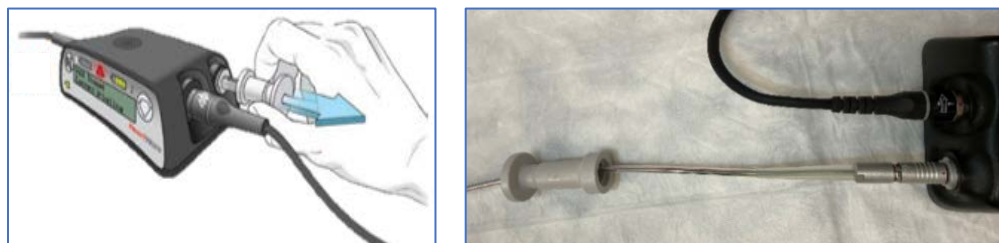
Figure 1

Difficulty in pulling back the driveline cover over a strain relief repair may cause a delay in accessing the driveline connector. This delay may lead to a prolonged pump stop if access to the driveline connector is required to address a marginal driveline connection or change controllers. In addition, pulling back the driveline cover over a driveline strain relief repair may compromise the integrity of the repair. In lab testing, the most common issue observed was the tape that overlaps the end of the driveline connector rolled back when pulling the driveline cover away from the controller.

A strain relief repair is intended to repair damage to the strain relief without requiring pump-off time for a driveline splice repair or a pump exchange. The potential difficulty in pulling back the driveline cover over the repair is not currently included in the labeling; therefore, we are communicating to clinicians so they can make informed risk/benefit decisions and appropriately manage their patients. Pulling back the driveline cover is required to access the driveline connector (see figure 1 below), for example, during a controller exchange to disconnect the driveline from the controller.

- Leave the driveline cover in place. Medtronic does not recommend to tamper with or cut off the Driveline cover or otherwise remove it.
- Advise patients that, whenever possible, controller exchanges should be performed under clinical supervision, as it will likely be difficult to pull back the driveline cover to access the driveline connector. When a prospective controller exchange is planned (e.g., when exchanging a controller that has exceeded its 2-year useful life), schedule a Medtronic Field Service Engineer to be present to assess the strain relief repair and evaluate the need for a splice repair, a more extensive repair requiring brief pump off time which replaces the distal end of the driveline including the connector and strain relief.

- Consider a splice repair to replace the portion of the driveline outside the patient's body. A splice repair requires pump-off time to replace the damaged area. The decision to perform a splice repair should be made on a case-by-case basis, considering the unique risks for each patient's ability to withstand pump-off time and risk acceptance.
