Urgent Field Safety Notice

HeartWare™ Ventricular Assist Device (HVAD™) System, Model 1104

Update to failure rates and recommendations

December 2021

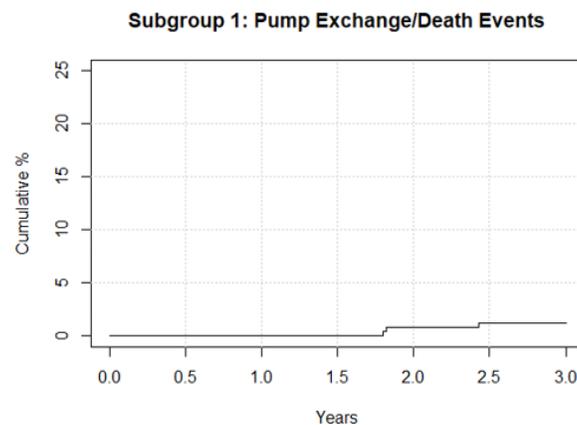
Subgroup 1: Pump Exchange/Death Events

- Subgroup 1 includes 316 distributed pumps manufactured from a single supplier lot of components, exhibiting 9 events of a delay or failure to restart, 2 of which involved a patient death. Our records indicate there are currently 97 patients on support with a pump from Subgroup 1.
- Subgroup 2 includes 174 distributed pumps manufactured from the 2 subsequent supplier lots of components, exhibiting 32 events of a delay or failure to restart, 8 of which involved a patient death. Our records indicate there are currently 48 patients on support with a pump from Subgroup 2.

Figure 1: Cumulative incidence of experiencing a pump stop with delay/failure to restart leading to a pump exchange or death in Subgroup 1

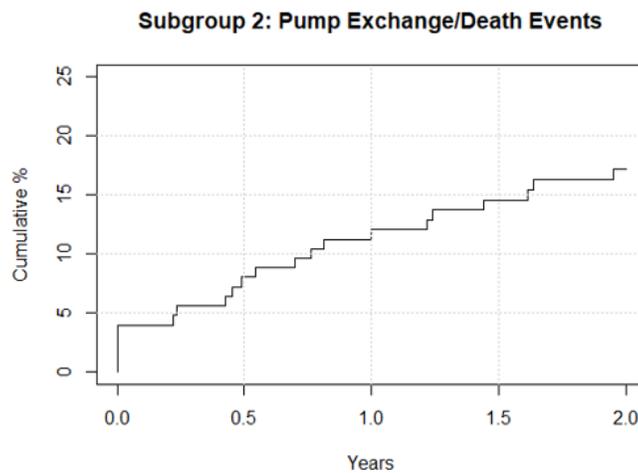
Subgroup 2: Pump Exchange/Death Events

Figure 2: Cumulative incidence of experiencing a pump stop with delay/failure to restart leading to a pump exchange or death in Subgroup 2
