Welch Allyn, Inc. 4341 State Street Road Skaneateles Falls, NY 13153 USA	<b>URGENT: Field Safety Notice</b>	FA-2021-05-001-SKF-004
-----------------------------------------------------------------------------------	------------------------------------	------------------------

Braun® ThermoScan® Pro 6000 Ear Thermometer

Potential risk of probe tip overheating

FSCA-identifier: FA-2021-05-001-SKF-004

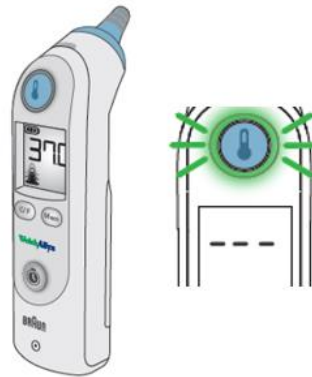
Our investigation has confirmed that the probe tip overheating is the result of fluid ingress. Fluid ingress causes the sensor to behave inconsistently, which does not allow the built-in safety mitigation (turn off the heating element) to work correctly. The majority of the devices which experience overheating of the probe tip show one of two behaviors at time of power up:

1. The ring around the measurement button will show a green blinking or flashing light instead of a ready state (solid green light).
2. The device requires multiple power-ups prior to going to ready state (solid green light).

1. Please share this communication with all potential users in your organization and instruct them to follow the provided Cleaning Guide for proper cleaning.
2. Do not use the device if the ring around the measurement button shows a green blinking or flashing light instead of a "ready state" (solid green light) and contact Hillrom Customer Service to report this issue.

3. Do not use the device if the device requires multiple power-ups prior to going to “ready state” (solid green light) and contact Hillrom Customer Service to report this issue.
4. If you experience an overheating probe tip, do not use the device and contact Hillrom Customer Service to report the issue.
5. Complete the attached response form and return to [HillromSKF004OUS@hillrom.com](mailto:HillromSKF004OUS@hillrom.com) within one month.
