<**References: 92705305 & 92289212-FA**>

Cover letter

Urgent Field Safety Notices:

Subject: Field Safety Notice – High Battery Impedance May Initiate Safety Mode in INGENIO™, VITALIO™, and ADVANTIO™ pacemakers and INLIVEN™, INTUA™, and INVIVE™ cardiac resynchronization therapy pacemakers (CRT-Ps) (Boston Scientific Field Action Reference: 92705305-FA).

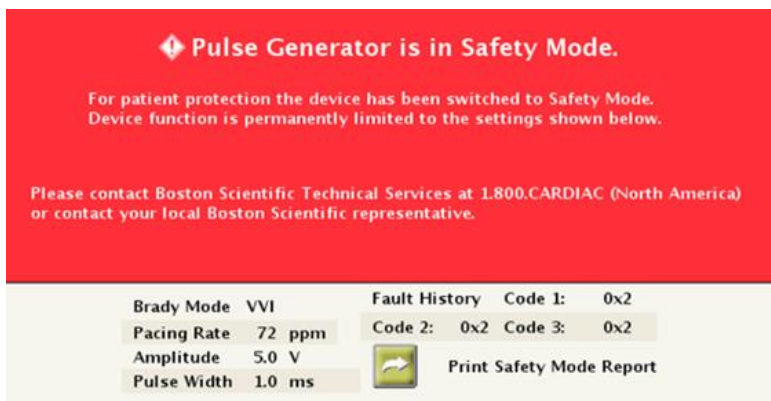
Figure 1. Programmer Warning Screen for Safety Mode

Boston Scientific transvenous pulse generators contain dedicated hardware to support overall safety architecture. In pacemakers and CRT-Ps, this hardware is intended to provide back-up pacing if certain non-recoverable or repeat fault conditions occur. Safety Mode is not intended to be a substitute for chronic pacing therapy. There is a high degree of detectability when a device is operating in Safety Mode. A warning screen is displayed on the programmer upon device interrogation (Figure 1). For those devices monitored via LATITUDE, a red alert will also be issued, indicating the device has entered Safety Mode. If a device is unmonitored for a period of 14 days, it will show up on the 'not monitored' status page on LATITUDE. Whenever a device enters Safety Mode operation, users are instructed to contact Boston Scientific, and Technical Services will advise device replacement.

2- Replacement. If a device enters Safety Mode, schedule replacement. Boston Scientific does not recommend general prophylactic replacement for affected devices. However, for individual patients, factors such as those listed above and shared decision-making may support consideration of early device replacement to mitigate unintended clinical impact(s) due to potential entry into Safety Mode prior to the Explant indicator. In these cases, the following guidance should be considered:
