Aptio Automation

Interface Module to the ADVIA® Centaur XP/XPT

This response form is to confirm receipt of the enclosed Siemens Healthcare Diagnostics Urgent Field Safety Notice (UFSN) LASW21-01.A.OUS dated October 2021 regarding the Aptio Automation Interface Module to the ADVIA® Centaur XP/XPT. Please read the statement below and indicate the appropriate answer.

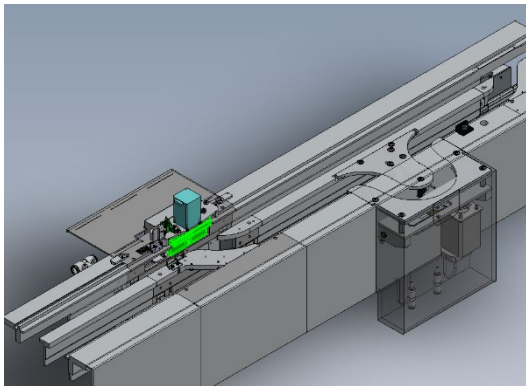
Image 1.a: ADVIA Centaur XP/XPT Interface Module (SMN 10703038)

The issue occurs when a sample tube that is to be processed by the ADVIA Centaur XP/XPT is not diverted into the Interface Module due to a mechanical issue or due to an obstruction. In this scenario, one of the following sample tube(s) that is diverted into the Interface Module in order to be processed by the ADVIA Centaur XP/XPT may be released from the Interface Module and flagged with the error code 3160 “Sampling Not Successful” and with test results obtained from another sample tube. According to the default Automation System configuration, the sample tube is flagged with error code 3160 and is sent into an Input/Output Module (IOM) Priority Output rack.

- there are no obstructions that prevent the correct activation and movement of the divert, refer to Image 1.a.
- the divert looks to be intact, refer to Image 2.a.
- the position of the diverter is aligned to the profiles when it is diverting a tube, refer to Image 3.a; tubes that need to be routed by the Analyzer are diverted fluidly, without any missing or partial block of the carrier.

A daily visual check on the divert of the Aptio Automation Interface Module to the ADVIA Centaur XP/XPT is required to verify that:

If the visual check does not pass, contact your local technical support for assistance.
