Atlan A300, Atlan A300XL

Atlan A350, Atlan A350XL

Important Safety Notice

Artefacts on pressure and flow curve

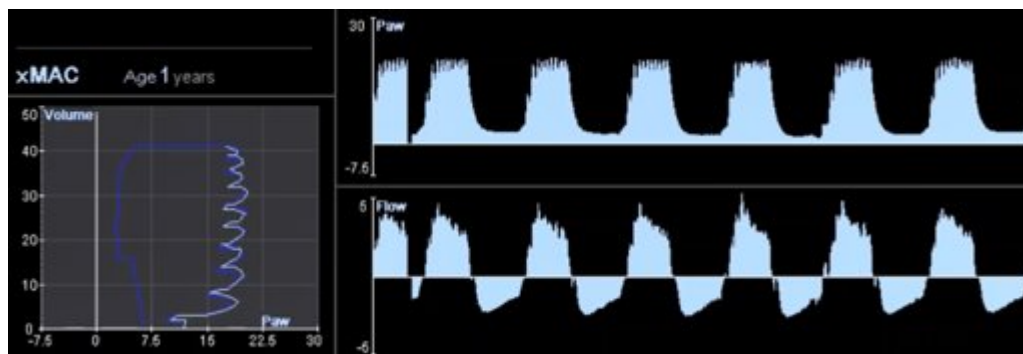
Artefacts on pressure and flow curve

During the course of our global market surveillance activities, we have become aware of very rare cases in which the Atlan Anesthesia Workstation with SW 1.01 has shown artefacts on the pressure and flow curves while the devices are being operated in one of the following ventilation modes: PC - CMV, PC - SIMV, PC - SIMV / PS, VC - CMV / Autoflow, VC - SIMV / Autoflow, VC - SIMV / PS / Autoflow, CPAP / PSV.

Our investigation revealed that these artefacts occur only in rare combinations of certain resistance and compliance combinations of the whole system of e.g. filters, breathing hoses, ET-tube, patient lung and leakages. Although these artefacts are visible on the displayed pressure and flow curve and may be audible during auscultation, the pressure or flow spikes will not reach the patients lungs, due to the low pass filter effect of the resistance in the endotracheal tube and the upper airways.

However, we cannot exclude that the pressure and flow pattern shown on the display might cause confusion to the clinical user, potentially resulting in an improper therapy decision. As of today, no injury has been reported to Dräger in this context.

Dräger is currently working on a software update, which will remedy the issue. Your local Dräger representative will contact you as soon as the new software is available, in order to schedule the device update. The software update will be provided free of charge

Until the software update is available you may continue using the device and affected ventilation modes, making sure that therapy decisions are not made based only on these artefacts.

Switching to one of the unaffected ventilation modes, will prevent occurrence of these artefacts.
