**URGENT FIELD SAFETY NOTICE  
MEDICAL DEVICE CORRECTION**

**MAQUET CARDIOSAVE hybrid and MAQUET CARDIOSAVE rescue**

<b>Product Code/Part Number:</b>	<b>0998-XX-0800-XX</b>
<b>Distributed Affected Lot Number:</b>	<b>All</b>
<b>Distribution Dates:</b>	<b>Since March 6, 2012</b>

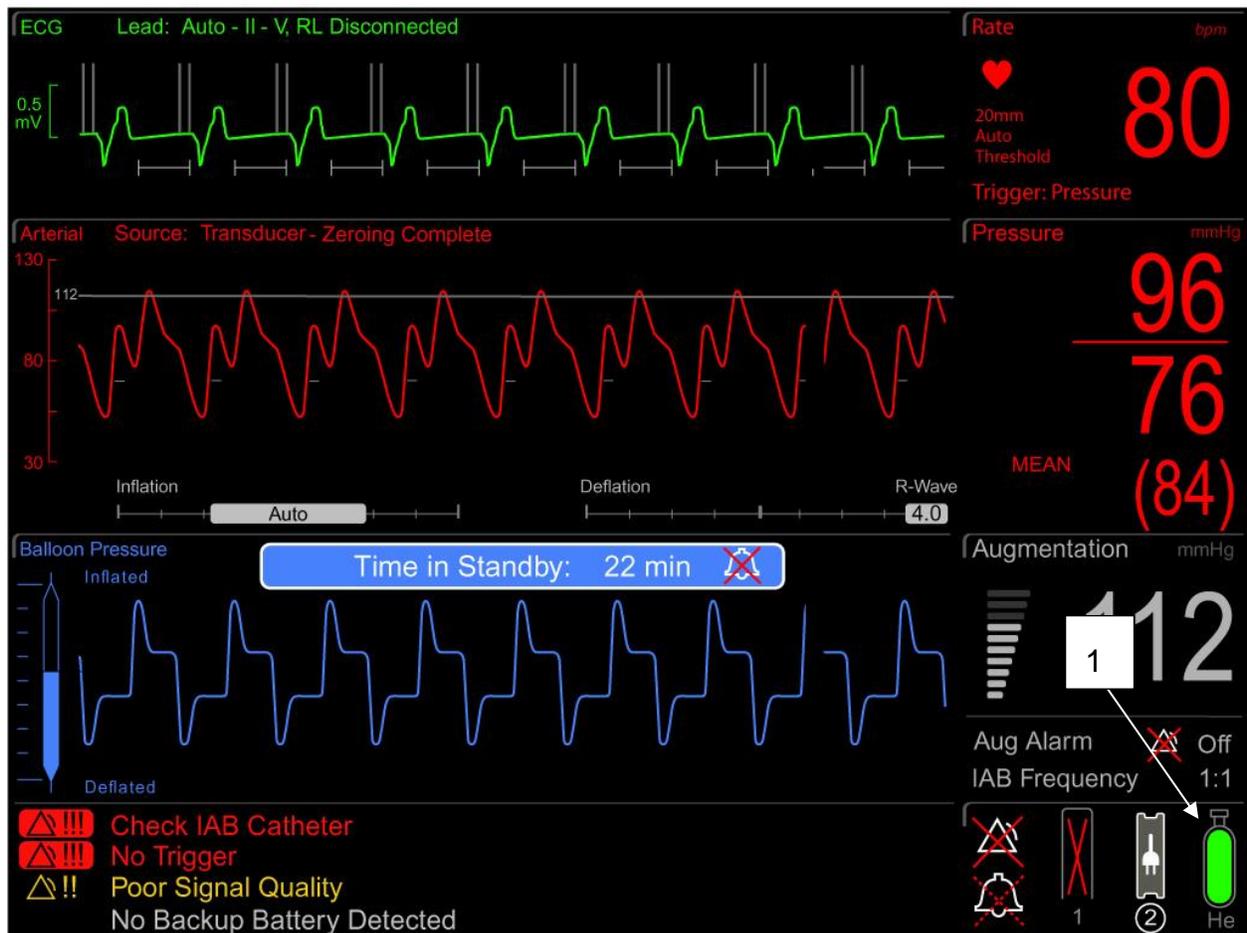
**Figure 1 – Monitor Display (1 – Helium Indicator)**

During Electromagnetic Compatibility (EMC) testing at an external lab, Getinge personnel determined that in the presence of some radiated RF disturbances, the Helium Indicator on the Cardiosave IABP (refer to Figure 1) would intermittently over-report the remaining Helium Capacity. Once the disturbance was removed the Helium indicator always fully recovered within 10 seconds to display the proper level without any over-reporting.

Getinge’s investigation revealed that the over-reporting of Helium Capacity would intermittently occur at frequency ranges between 80 MHz – 1 GHz. Potential sources of interference include: radio communication, cell phone, Wi Fi, RFID equipment and equipment that does not meet current electromagnetic compatibility standards.

It is important to note that upon removal of the source of EMC interference the Helium Indicator performs as intended.

Users should perform the following actions to limit the possibility of loss of therapy due to an over-reporting of remaining helium on the Helium Indicator.

Datascope/Getinge is developing a hardware correction to address this issue. A Datascope/Getinge service representative will contact you to schedule the installation of the correction when available. This work will be done at no cost to your facility.

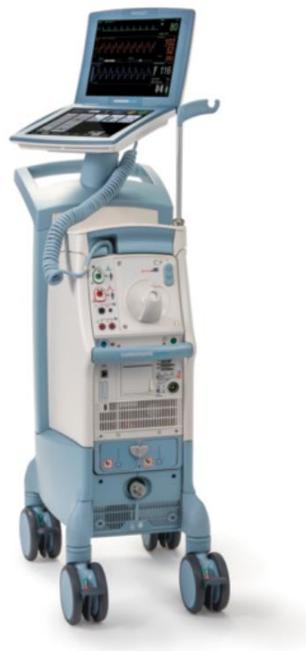
**Figure 3: Cardiosave in Hybrid Configuration**

The Cardiosave IABP may unexpectedly shut down when the device is running on AC power, only one battery is installed in the IABP, and the battery is physically removed while the battery is being charged. An audible sudden shutdown alarm will sound if this condition occurs. This issue can only happen in the presence of clinical personnel as the battery must be physically removed.

Unexpected shutdown can only happen while in Hybrid Configuration (Figure 3) when all four of the below conditions are met:

1. IABP is running on AC power and charging a single battery in voltage charging mode. Voltage charging mode occurs during the last 15-20 minutes of the full charging cycle, when the 5<sup>th</sup> and final LED charge indicator on the battery pack is flashing.
2. The other battery bay is empty, i.e. no battery is inserted into the second battery bay.
3. The battery is ejected while a system signal erroneously reports the AC power supply is low, this will only happen intermittently when the first two conditions are met.
4. Battery is ejected when all above conditions are met.

To ensure that the Cardiosave Hybrid is not susceptible to the shutdown during the removal of a battery, users should not eject a battery when:

- There is a singular battery in either battery charging bay and unused battery bay is empty.
- The battery is charging on AC power (indicated by a flashing LED on the battery pack).

Additionally, the user can prevent the issue by ensuring that a battery is inserted into each of the two battery bays. Should a charging battery be ejected inadvertently, the unit will automatically switch over to the second battery, thus preventing system shutdown.

Furthermore, Datascope/Getinge is developing a software correction to address this issue. A Datascope/Getinge service representative will contact you to schedule the installation of the updated software. This work will be done at no cost to your facility.

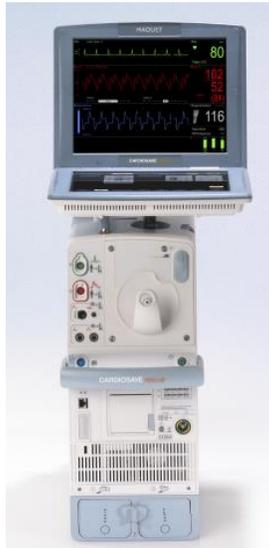
**Figure 4: Cardiosave in Transport Configuration**

An unexpected shutdown upon battery removal cannot occur for Cardiosave Rescue.
