UPDATE
URGENT FIELD SAFETY NOTICE
MEDICAL DEVICE CORRECTION

MAQUET CARDIOSAVE hybrid and MAQUET CARDIOSAVE rescue

Product Code/Part Number:	0998-XX-0800-XX
Distributed Affected Lot Number:	All
Distribution Dates:	Since March 6, 2012

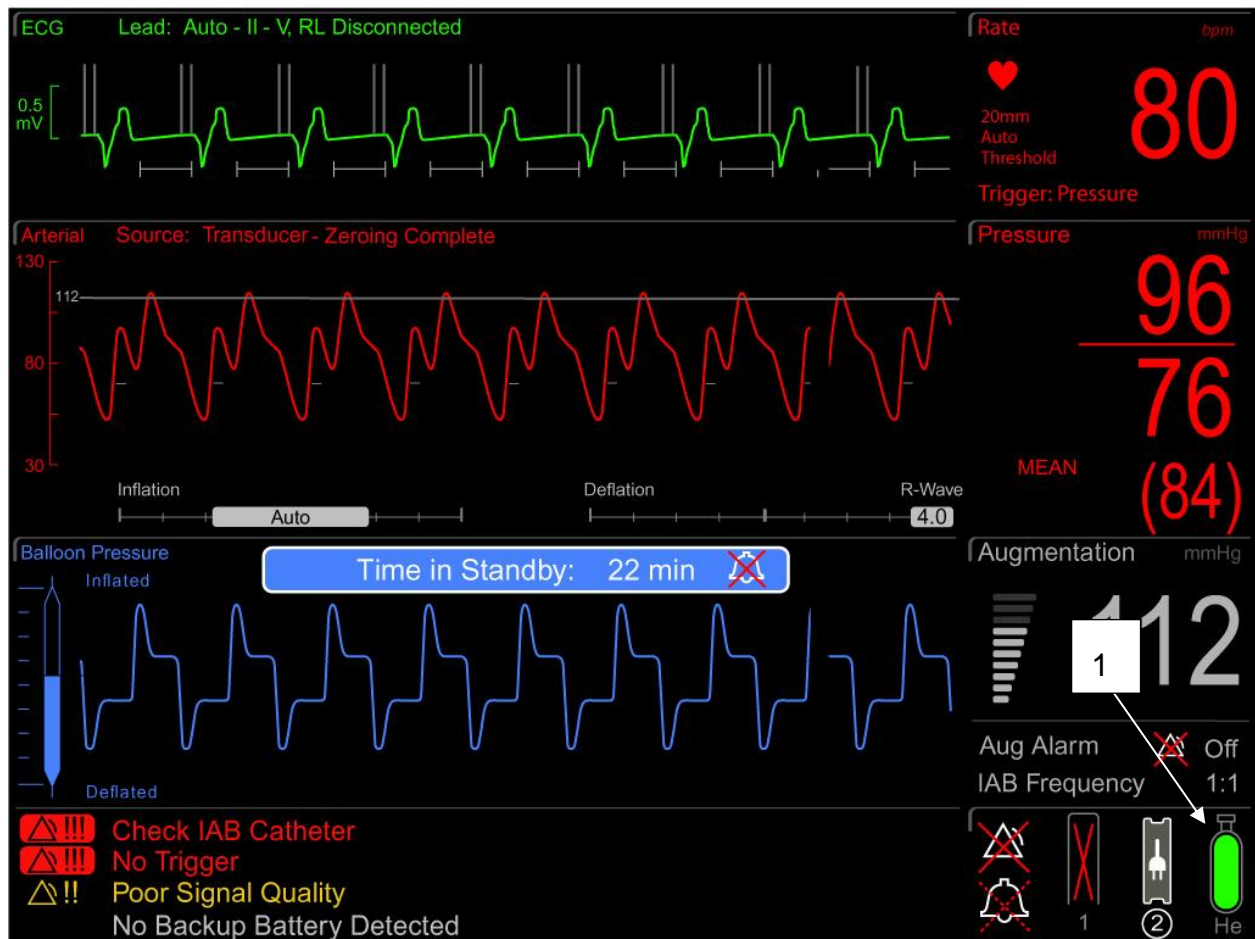
Figure 1 – Monitor Display (1 – Helium Indicator)

During Electromagnetic Compatibility (EMC) testing at an external lab, Getinge personnel determined that in the presence of some radiated RF disturbances, the Helium Indicator on the Cardiosave IABP (refer to Figure 1) would intermittently over-report the remaining Helium Capacity. Once the disturbance was removed the Helium indicator always fully recovered within 10 seconds to display the proper level without any over-reporting.

Getinge’s investigation revealed that the over-reporting of Helium Capacity would intermittently occur at frequency ranges between 80 MHz – 1 GHz. Potential sources of interference include: radio communication, cell phone, Wi Fi, RFID equipment and equipment that does not meet current electromagnetic compatibility standards.

It is important to note that upon removal of the source of EMC interference the Helium Indicator performs as intended.

Datascope/Getinge is developing a hardware correction to address this issue. A Datascope/Getinge service representative will contact you to schedule the installation of the correction when available. This work will be done at no cost to your facility.

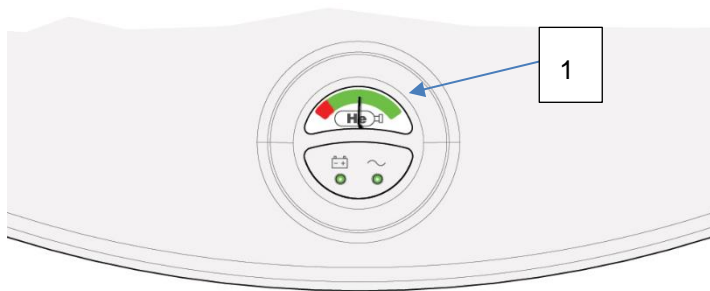
Figure 2 – Top Panel (1 – Mechanical Helium Gauge)

Since the mechanical gauge is not influenced by EMC, view the mechanical gauge on the Cardiosave Top Panel (See figure 2) to assess remaining helium capacity in case of suspected EMC disturbances.

Where practical, maximize separation of Cardiosave system from other electronic equipment, communication devices and cables (e.g. power and communication cables). In particular, follow the recommended separation distances between communications equipment and the Cardiosave equipment as specified in the Cardiosave Operating instructions manual.

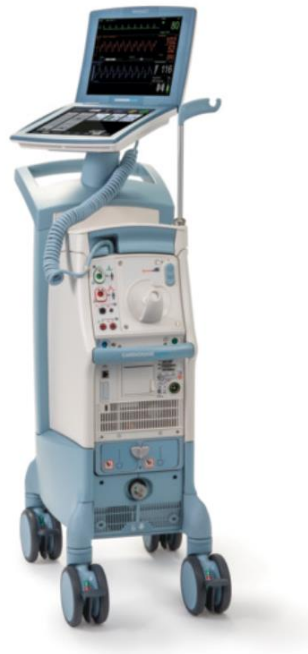
Figure 3: Cardiosave in Hybrid Configuration

The Cardiosave IABP may unexpectedly shut down when the device is running on AC power, only one battery is installed in the IABP, and the battery is physically removed while the battery is being charged. An audible sudden shutdown alarm will sound if this condition occurs. This issue can only happen in the presence of clinical personnel as the battery must be physically removed.

Unexpected shutdown can only happen while in Hybrid Configuration (Figure 3) when all four of the below conditions are met:

1. IABP is running on AC power and charging a single battery in voltage charging mode. Voltage charging mode occurs during the last 15-20 minutes of the full charging cycle, when the 5th and final LED charge indicator on the battery pack is flashing.
2. The other battery bay is empty, i.e. no battery is inserted into the second battery bay.
3. The battery is ejected while a system signal erroneously reports the AC power supply is low, this will only happen intermittently when the first two conditions are met.
4. Battery is ejected when all above conditions are met.

To ensure that the Cardiosave Hybrid is not susceptible to the shutdown during the removal of a battery, users should not eject a battery when:

- There is a singular battery in either battery charging bay and unused battery bay is empty.
- The battery is charging on AC power (indicated by a flashing LED on the battery pack).

Additionally, the user can prevent the issue by ensuring that a battery is inserted into each of the two battery bays. Should a charging battery be ejected inadvertently, the unit will automatically switch over to the second battery, thus preventing system shutdown.

Furthermore, Datascope/Getinge is developing a software correction to address this issue. A Datascope/Getinge service representative will contact you to schedule the installation of the updated software. This work will be done at no cost to your facility.

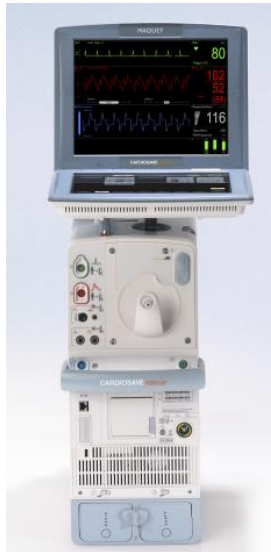
Figure 4: Cardiosave in Transport Configuration

An unexpected shutdown upon battery removal cannot occur for Cardiosave Rescue.
