**URGENT FIELD SAFETY NOTICE  
 MEDICAL DEVICE CORRECTION  
 FSCAs 2249723-06/02/2023-010-C, 2249723-06/02/2023-011-C,  
 2249723-06/02/2023-013-C & 2249723-06/02/2023-014-C  
 Datascope Cardiosave Hybrid and Rescue Intra-Aortic Balloon Pumps (IABP)**

Datascope Corp., a subsidiary of Getinge is initiating a voluntary Medical Device Correction for the Cardiosave Hybrid and Cardiosave Rescue Intra-Aortic Balloon Pump (IABP) due to the following four (4) identified system conditions:

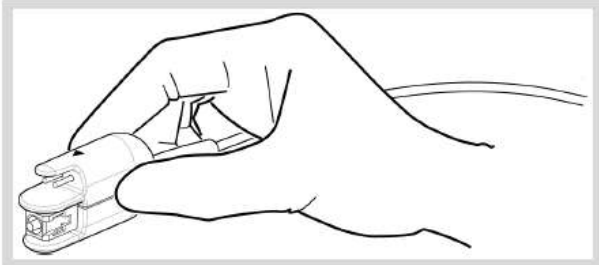
*Figure 2-5: Grasping the Fiber-Optic sensor connector*

The Fiber Optic connector is designed to fit smoothly into the IAB Sensor Input. The red triangle on the top of the connector should align with the red triangle on the Cardiosave console. Inserting the Fiber Optic connector into the port without verifying the correct alignment can lead to internal damage. If difficulty is encountered when inserting the connector, verify that the connector is in the correct position and attempt to reinsert into the IAB Sensor Input.

Excessive force can cause damage to the connector and the internal fiber optic assembly of the IABP console. This may cause a disruption in the fiber optic signal acquisition resulting in an inability to acquire a fiber optic signal on the Cardiosave IABP. Following proper insertion procedures will minimize the potential for damage to the connector and a loss of signal. This conclusion is based on field observations seen through the complaints evaluation. As part of Datascope's investigation testing will be performed to confirm this observation.

Damaged Fiber Optic ports may not present as an immediate failure. There is a potential for the damage to cause an intermittent or delayed failure in the Fiber Optic connection.

1. With one hand, grasp the Fiber-Optic Sensor Connector as shown in Grasping the Fiber-Optic sensor connector, with the red triangle visible on top.

**Note:**  
Ensure that the red triangles on the Fiber-Optic IAB Sensor Connector and on the back panel are in alignment.

In step 4, when the Fiber-Optic connector is inserted into the IAB Sensor input until an audible "click" is confirmed, ensure that you are not using excessive force as that can lead to damage to the Cardiosave.
