Our reference: FSCA-2023-08-14 (1)

Date: August 14, 2023

## URGENT Field Safety Corrective Action Infusomat® Space - Upstream Occlusion Sensor

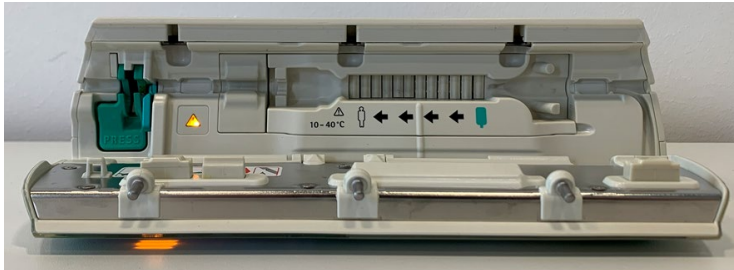
1. Open the pump door.

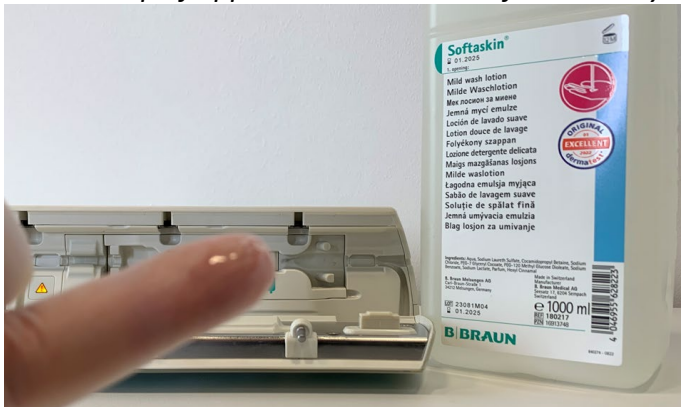
2. Take a drop of approx. 0.1 to 0.2 ml Softaskin® to your finger.

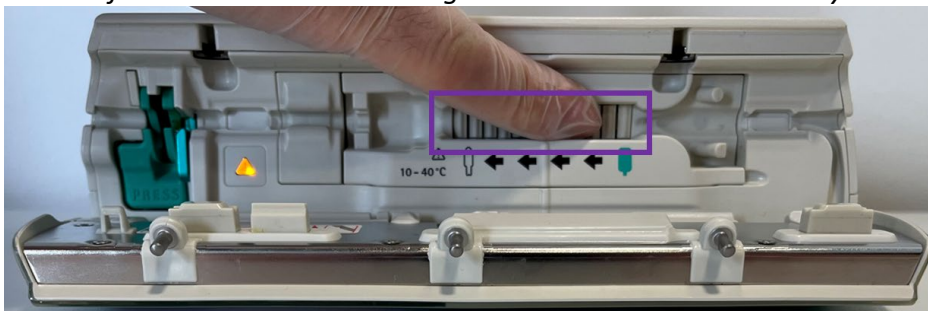
3. Bring the Softaskin® onto the peristalsis of the pump and distribute it evenly in the marked area. Softaskin® must not be brought onto air sensor above the yellow warning light.

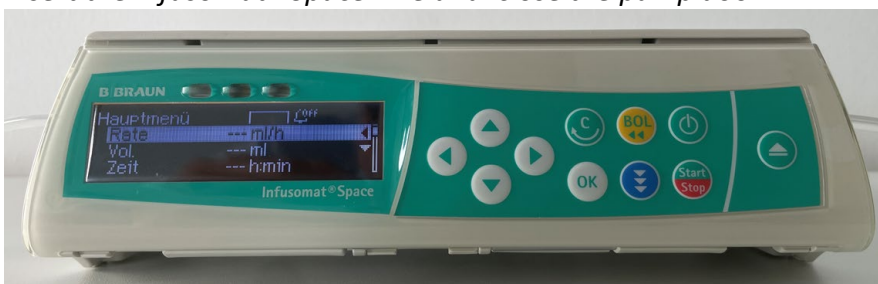
4. Insert the Infusomat® Space Line and close the pump door.
