Reference number: CAPA00776

**Urgent Field Safety Notice**

The purpose of this letter is to notify you that we have initiated a Field Safety Corrective Action for the Syringe Tray Code No. 992678 that is used with the Dako Autostainer instruments (AS480; AS100; S3400; S3800). Our records show that you may have one or more Dako Autostainer instruments without a Syringe Tray.

### Installation of Syringe Tray

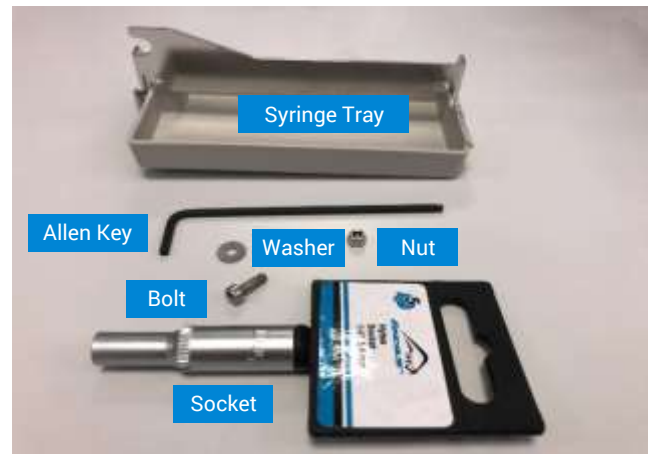
Figure 1.

Have the Syringe Tray kit available, Figure 1

Tools (socket and Allen key), bolt, washer and nut are included with the kit

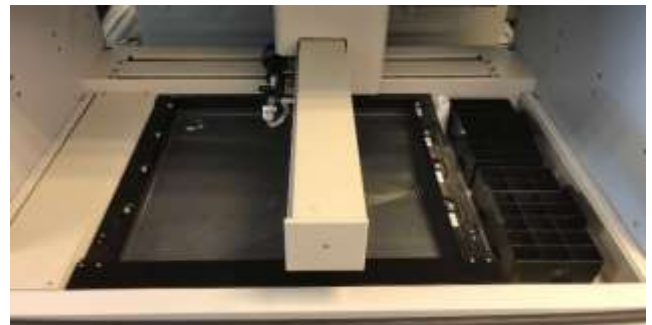
Figure 2.

- Turn off the instrument
- Move the robot arm by hand to the middle of the instrument, Figure 2
- If present, remove the cable tie from the lower right hole on the syringe bracket, Figure 3
- Place the washer on the bolt, Figure 4
- Place the nut in the socket. It is recommended to stop the nut from sinking down the socket by adding a small piece of material, such as paper, in the hole before the nut is placed in the socket, Figure 4
- Locate the hook on the Syringe Tray, Figure 5

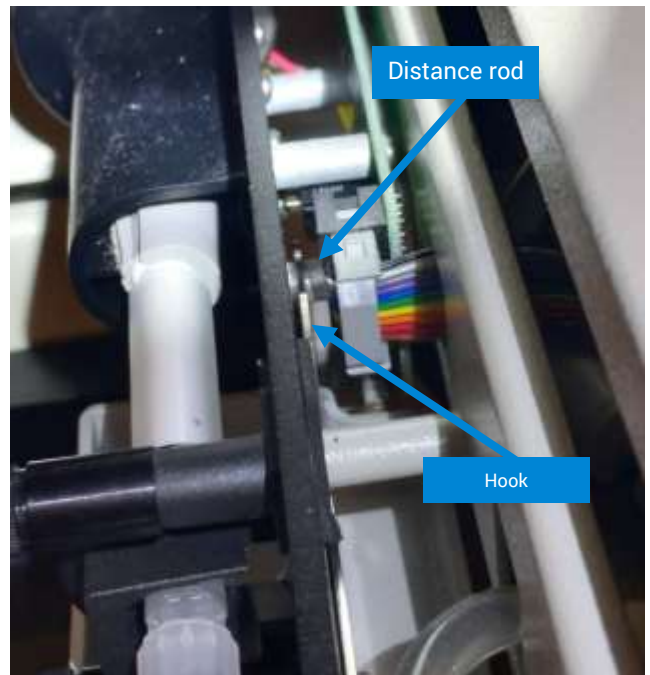
Figure 6.

- With your right hand, slide the hook part of the Syringe Tray Bracket over the Distance rod, Figure 6
- With your left hand, install the small bolt and washer from the syringe side in the lower hole, Figure 7
- Use the socket to mount the nut from the backside, Figure 8
- Use the Allen key and socket to hand tighten the bolt/nut, Figure 8
- Figure 9 depicts the final solution

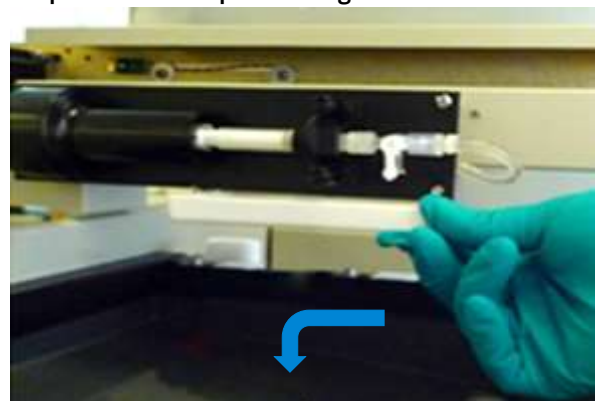
Figure 10.

**Note:** To prime the stopcock (when needed), tilt the Syringe Tray by pushing the tray against the syringe, and down. The tray will be tilted back to the horizontal position, by spring force, and snap-locked in this position. Figure 10
