**URGENT  
FIELD SAFETY NOTICE (FSN)  
MEDICAL DEVICE RECALL  
MULTIPLE GOLD CUP ELECTRODES and SNAP ELECTRODE LEADS**

Natus reference: CAPA004513

#### Description of issue

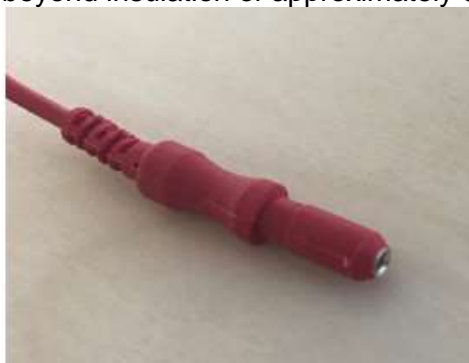
Image 1: Electrode lead connector to main device.

You are receiving this notification because Natus Medical Denmark, going on the market under the GN Otometrics A/S brand name, is conducting a voluntary recall for the gold cup electrodes and electrode leads. Our records show that you received at least one of the gold cup electrodes and snap electrode lead at your location. The electrode lead connector has a protruding conductor beyond insulation of approximately 0.1 mm.

It has been determined that the device does not fully meet the current regulatory standard for basic electrical safety and essential performance. There is a potential risk to the healthcare professional or patient of exposure to electrical shock from the electrode connector.

Natus requests that you do not use the electrode leads and return them.

1. Identify and quarantine the affected electrode leads. Cease use of all affected electrode leads immediately.
2. Review this communication in its entirety and ensure that all users of the listed products in your organization are informed of this notification.
3. Distribute this notification to all associated parties within your organization.
4. Complete and return the Verification Form enclosed in this letter via e-mail, fax or postal mail.
5. Contact Natus or your Authorized Natus Distribution Partner for assistance in returning your gold cup electrodes or snap electrode leads.
6. Return the electrode leads to the below address with a copy of the completed customer reply form:

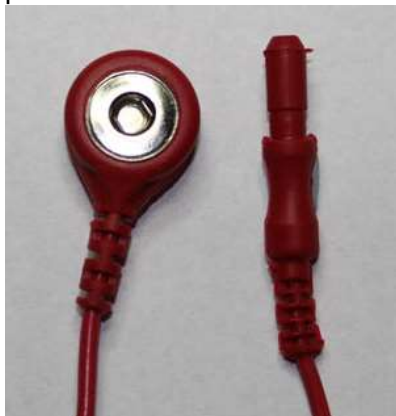
Image 2: Snap Electrode lead

Snap, cable, and connector are all the same color: red, blue, green, brown, orange, white, black, or yellow. The connector has an angled taper as shown in the image below. No text or actual printed/molded identifiers are located on the leads.

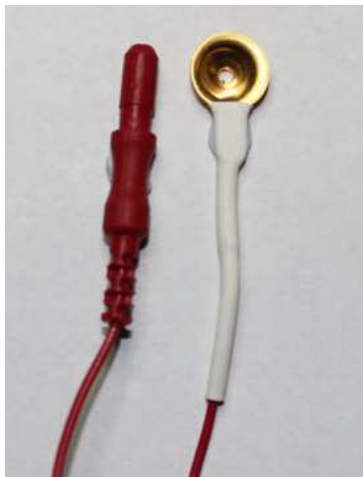
Image 3: Cup Electrode lead

Connector and cable have the same color; there is a white transition between the cup and cable. The connector has an angled taper as shown in the image below. No text or actual printed/molded identifiers are located on the leads.
