AX068/20/S

Customer Safety Information (CSI) for Field Safety Corrective Action

Subject: Addendum of the tooth belt cleaning for AXIOM Artis, Artis zee, Artis Q and Artis Q.zen

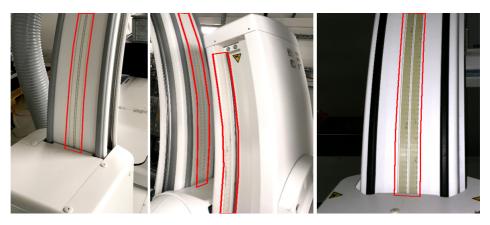
Examples of belts

Safety information - cleaning units which have a visible belt

Pay special attention when cleaning units (stands) which are equipped with a visible belt.

Observe the following information for cleaning:

- Do *not use* cleaning agents containing *aldehydes*.
- Do not use spray bottles.
- Perform *dry* cleaning, if possible.
- Use *little* cleaning agent or only water, if possible.
- ◆ Wipe dry.
