Subject: URGENT - FIELD SAFETY NOTICE – Integra – Codman® CereLink® ICP Monitor, Model: 826820: ICP Monitor Reading Default – Field Safety Notice

826820 - Codman® CereLink® ICP Monitor
All serial numbers ranging from CLK2111003 to CLK2215542

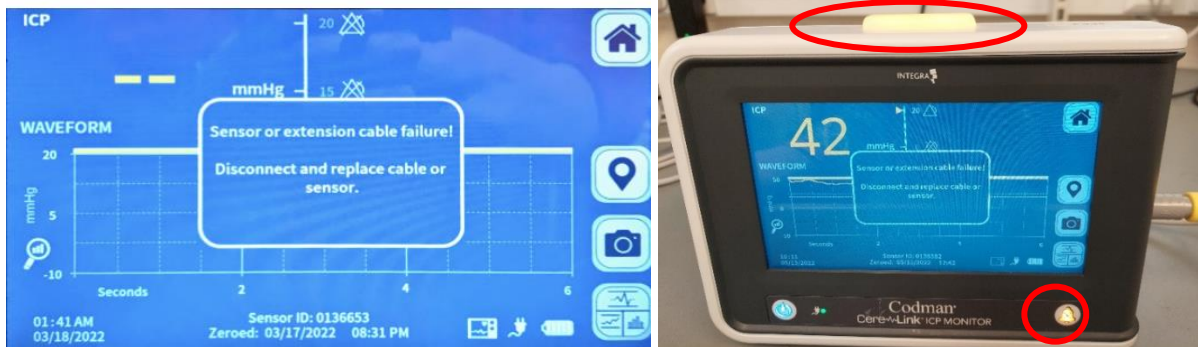
Figures 1 (left) and 2 (right): Visual alarms including display and flashing light alarm

- Per standard clinical practice, patients are consistently monitored at the patient bedside, making it more likely that an abnormal ICP would be detected using clinical exam and other vital signs.
- Audible and visual alarms on the CereLink® ICP Monitor are triggered in the event of an out-of-range reading to inform the user that the failure mode is occurring (see Figures 1 and 2).

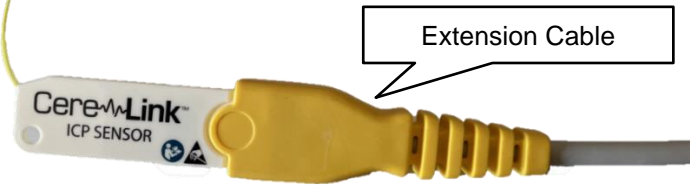
| 1. | <p>Make sure the CereLink® ICP Sensor is connected correctly (fully seat) into the CereLink® ICP Extension Cable (included with the monitor; also available separately under product code 826845).</p> |

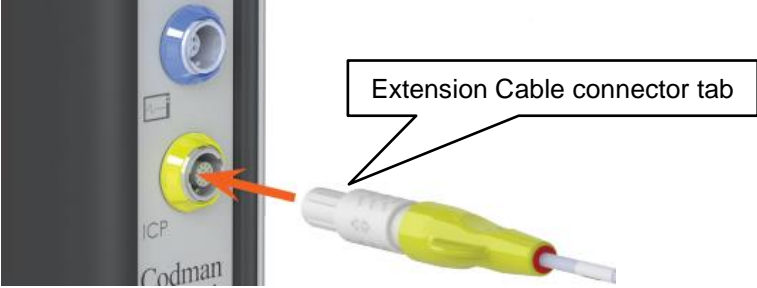
| 2. | <p>Make sure the CereLink® ICP Extension Cable is connected correctly to the CereLink® ICP Monitor.</p> <ul style="list-style-type: none"> • Extension Cable connector tab and arrows should face forward, in same direction as the monitor screen. • Push yellow connector into yellow port until you hear a click. |

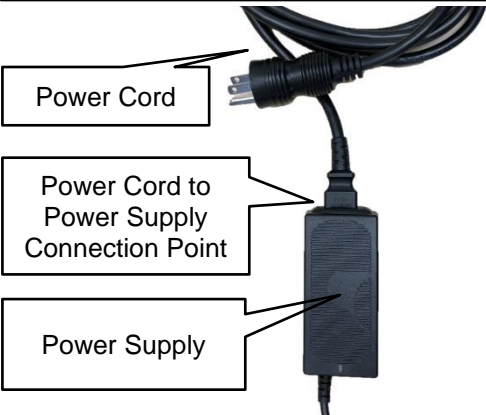
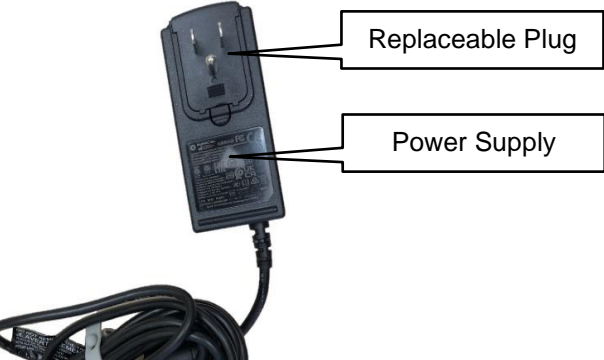
| 5. | <p>The CereLink® Power Supply comes with the CereLink® Monitor. The connection between the CereLink Power Supply and the outlet could come in two configurations: 1) a power cord or 2) a replaceable plug. Please ensure both are properly attached (see below).</p> <div style="display: flex; justify-content: space-around;"> <div style="text-align: center;"> <p>Power Cord Configuration</p> <p>Power Cord</p> <p>Power Cord to Power Supply Connection Point</p> <p>Power Supply</p> </div> <div style="text-align: center;"> <p>Replaceable Plug Configuration</p> <p>Replaceable Plug</p> <p>Power Supply</p> </div> </div> |
