FSN Ref: FSCA_20210426_Peristeen Plus_FSN
FSCA Ref: FSCA_20210426_Peristeen Plus

Urgent Field Safety Notice
Peristeen Plus

Peristeen Plus

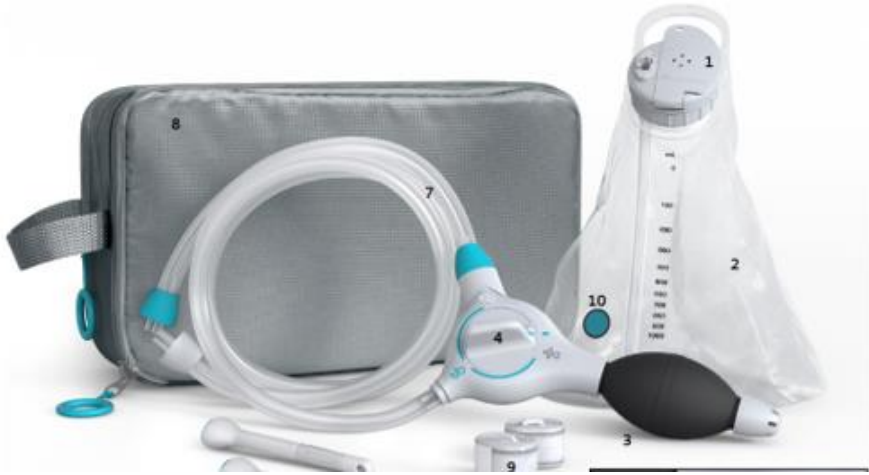
1. Information on Affected Devices*	
1	1. Device Type(s)*
.

1	2. Commercial name(s)
.	Peristeen Plus water bag
1	3. Unique Device Identifier(s) (UDI-DI)
.	Peristeen Plus Transanal Irrigation with balloon catheters – system and accessories Peristeen Plus Transanal Irrigation with cone catheters – system and accessories
1	4. Primary clinical purpose of device(s)*
.	Peristeen Plus TAI system is intended to promote evacuation of the contents in the lower and the descending colon. The Peristeen Plus accessories are intended to be used as part of the TAI systems.
1	5. Device Model/Catalogue/part number(s)*
.	291400, 291410, 291420, 291440, 291470, 291480, 291490, 291510, 291520, 291600, 291610, 291620
1	6. Software version
.	Not applicable
1	7. Affected serial or lot number range
.	CH: 7889760, 7889761, 7889765 DE: 7889735, 7889736, 7889742, 7889748, 7889759 ES: 7889767, 7889768, 7889769, 7889773, 7889774 FIN: 7838870, 7838871, 7838872, 7838876, 7838878, 7838880, 7838882, 7838885 NL: 7838833, 7838834, 7838837, 7838838, 7838841, 7838842, 7838843, 7838844, 7838845, 7838846, 7960980, 7960981, 7951008, 7951010, 7932846 NO: 7838860, 7838861, 7838865, 7838867, 7838868, 7838869 SE: 7838846, 7838847, 7838853, 7838854, 7838855, 7838857, 7838859, 7889780, 7889782, 7889784 UK: 7889730, 7916177
