URGENT FIELD SAFETY NOTICE

FSCA Reference: FSCA 745922 - HLS & PLS Set - potentially compromised sterile barrier

FSN Type: Update

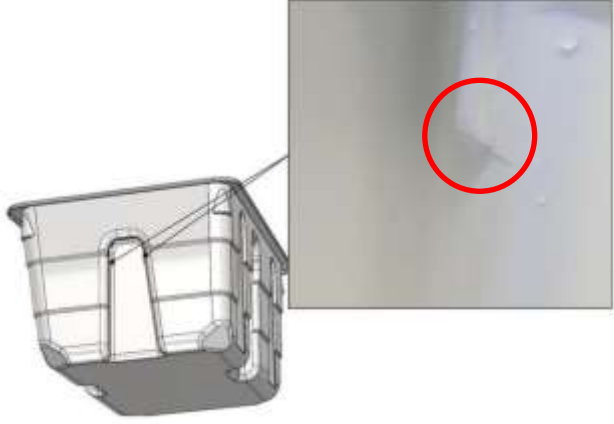
<p>Error case 1 (HLS+PLS): Damage on primary packaging (intellipack) caused by production process failure:</p> <p>In course of sterile barrier system integrity tests, MCP has determined a <u>defect (visible cracks)</u> in the intellipack packaging tray that can occur during production. <u>Cracks</u> may compromise the integrity of the sterile barrier of the HLS/PLS sets.</p> <p>Corrective Action implemented on 2023-03-07: Change of production process and introduction of 100% inspection.</p>

<p>Area on the intellipack packaging tray where the failure was detected with crack</p>

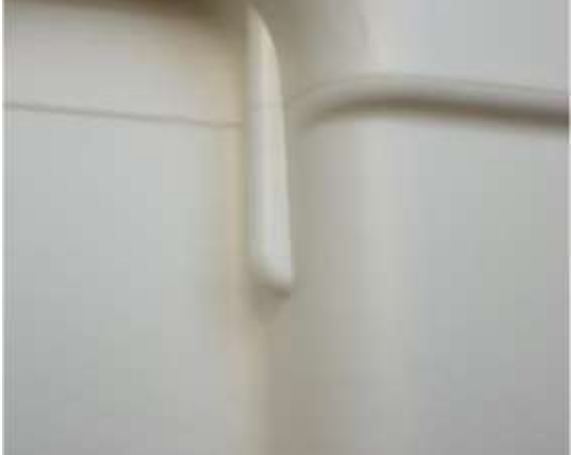
<p><u>Conform:</u> Undamaged, unstressed intellipack packaging tray</p>

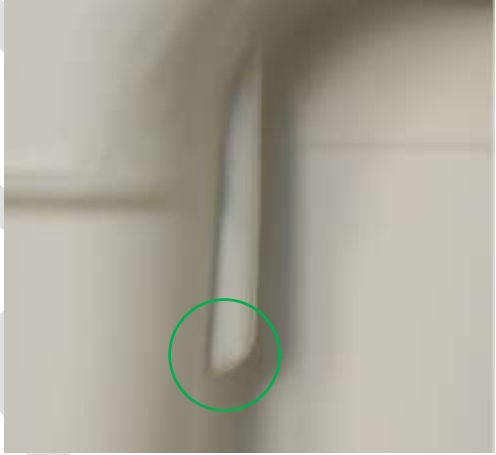
In the meantime, MCP has conducted further investigation into the error cases, specifically, the "white stress marks". All samples used passed through a real transport route and were tested for integrity afterwards. The tests have shown no evidence that the "white stress marks" have a negative impact on sterility. In addition, none of the retrospectively inspected sets returned from customers have shown any breaches in sterile barrier. In conclusion, there is no increased risk for patients or users due to the "white stress marks".

<p><u>Conform:</u> White stress marks on intellipack packaging tray</p>

Following this investigation, MCP has updated Annex II Instruction for visual inspection to define products with "white stress marks" as conforming and suitable for use.

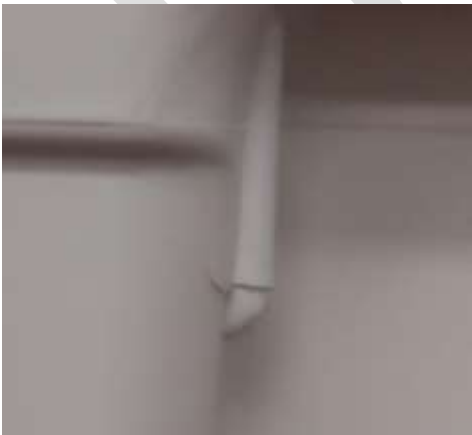
<p><u>Not conform:</u> Crack in intellipack packaging tray</p>

- Perform a visual inspection of the primary packaging, check for visible damages (cracks, holes etc.) in the packaging according to error case 1 (HLS + PLS) and 2 (HLS) described above. In case of visible damages in the packaging, do not use the product and return for replacement or credit note. Please refer to Annex II for a detailed instruction on how to check your products for the respective error cases.

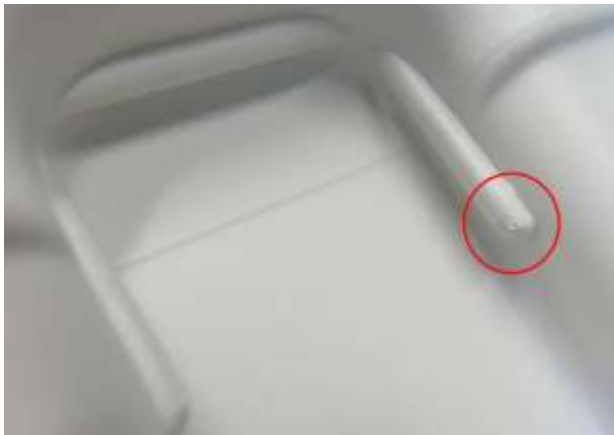
<p><u>Not conform:</u> Hole in intellipack packaging tray</p>

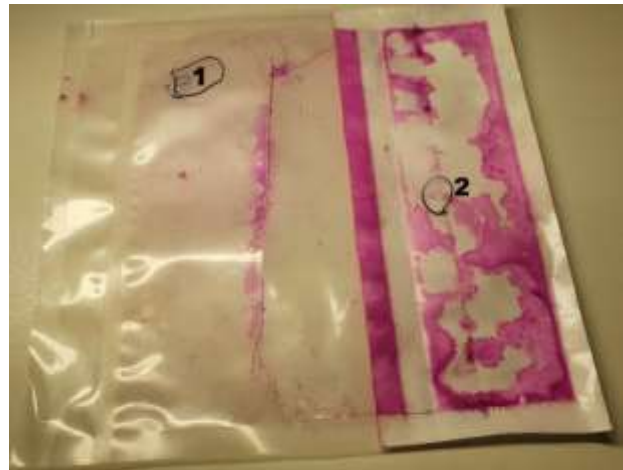
Damage of the component Tyvek pouches. Combination of production process error and transport stress can lead to perforation of the secondary packaging. This defect may compromise the integrity of the secondary sterile barrier of the HLS sets.

(The picture is merely for visualization of ink testing under laboratory conditions and was included for completeness purposes.)

Corrective Action implemented on 2023-03-07:
Change of packaging process and implementation of 100% inspection.
