## Urgent Field Safety Notice

**New warning in Instructions for Use for Ambu® aView™ 2 Advance**

**Ambu A/S - Single Registration (SRN): DK-MF-000001437**

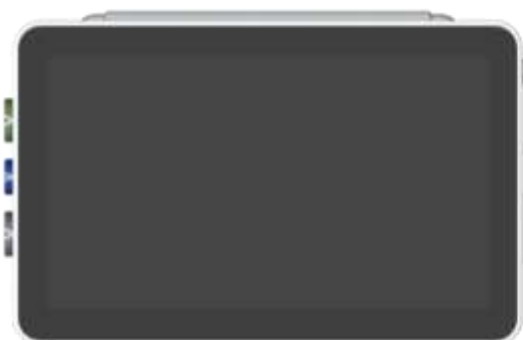
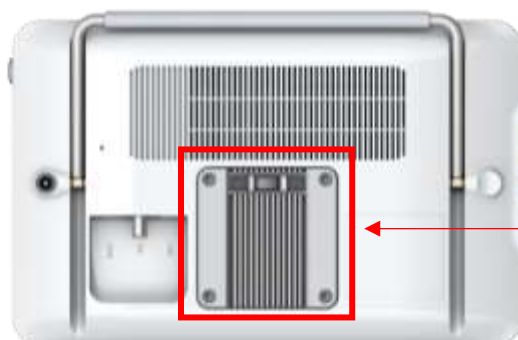
← VESA interface for mounting on medical carts

Ambu has received information on two incidents where Ambu® aView™ 2 Advance caught fire when mounted on the VESA holder of the aCart™ Compact, due to the screws used entering the lithium-ion battery of the device. No patients or staff members were harmed during the incidents.

Upon conducting a comprehensive investigation, we have identified the root cause of these incidents. The fire hazard was a direct consequence of a battery short-circuit, which, in turn, was triggered by the use of excessively long screws to secure the device on the VESA holder. The longer screw lengths inadvertently penetrated the lithium-ion battery, leading to the fire hazard.

*Use only M4 screws with the length of 14 – 16 mm when mounting Ambu aView 2 Advance on a VESA interface. Using longer screw lengths will penetrate the lithium-ion battery and result in a fire hazard and battery leakage which can cause severe burns, smoke inhalation and skin irritation. Using shorter screw lengths could result in unsecure device fastening.*
